PG&E Battery Energy Storage Pilot Projects Safety Plans and Lessons Learned

August 19, 2015

Jon Eric Thalman
Director Regulatory Strategy &
Transmission Asset Management

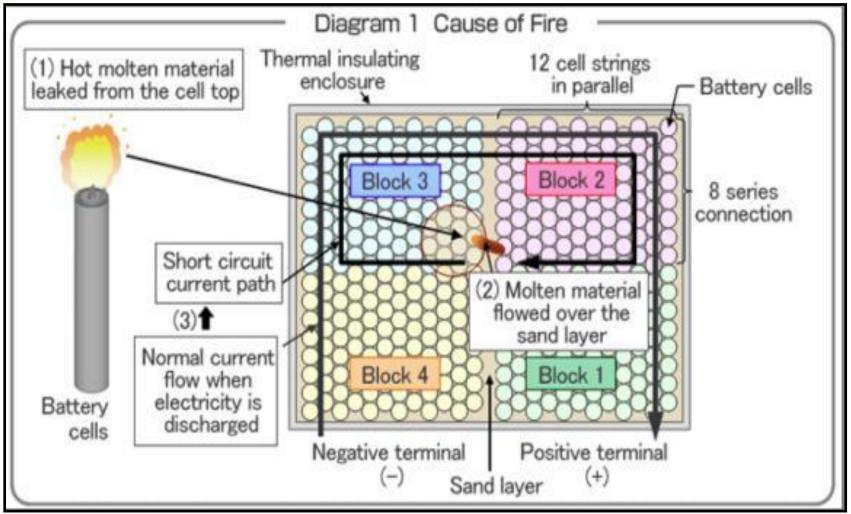
Cause of Fire (ctd)

- Molten material from a faulty cell leaked and caused a short between battery cells in an adjoining block.
- Due to lack of sufficient fuses the resulting heat, from the short-circuit, caused a number of other battery cells to catch on fire. This fire spread to the whole battery module.
- The combustion of the particular battery module released flames and hot molten material that melted battery cell casings inside battery modules, which caused the fire to spread further.
- Sodium battery fires (like lithium-ion battery fires) are difficult to extinguish because water cannot be used. The primary mitigation measures are shut down the battery to stop electric flow into the fault and to let the fire burn itself out.

- Fuses were added between individual batteries in each module to prevent a short-circuit current from causing a fire.
- Insulation boards were placed between blocks in each battery module to prevent leaking molten materials from causing a short circuit.
- Anti-fire boards were placed between battery modules above and below to prevent fire from spreading to other battery modules.
- Monitoring system put in place to enable quick fire detection
